**Flood Control Project Maintenance  
Levee Inspections****LMA District Cover Sheet****Spring 2014 Levee Inspection Results****Sacramento River West Side Levee District**

**Spring 2014 Levee Inspection Results**

**Sacramento River West Side Levee District**

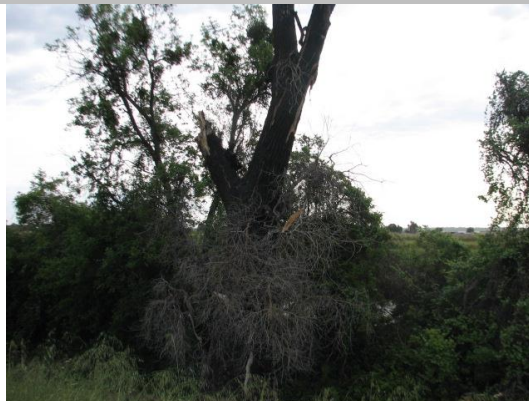
Photo 1 of 1 : johngw\_s\_20140428\_866.jpg

LM Start	1.28	Rating **	A/W	Issue No.	82
LM End	1.28	Issue Type +	Ma	Location *	WS
Category	Earthen Levee			GPS Latitude/Longitude	
				Start	End
Item	Vegetation			38.817036 °	38.817036 °
				-121.725410 °	-121.725410 °
DWR ID	DWR_NA0016_01_s _ 2014_82				
Action/Comments					
Trees / Woody Vegetation

Monitor trees that could pose a threat to the integrity of the levee. Spring 2014

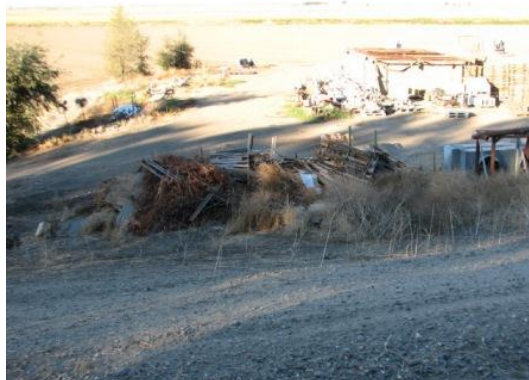
Photo 1 of 2 : johngw\_s\_20140414\_769.jpg

LM Start	2.42	Rating **	M	Issue No.	1550
LM End	2.42	Issue Type +	En	Location *	LS
Category	Earthen Levee			GPS Latitude/Longitude	
				Start	End
Item	Encroachments			38.832203 °	38.832203 °
				-121.729278 °	-121.729278 °
DWR ID	DWR_NA0016_01_f_2013_1550				
Action/Comments					
Debris

Debris is collected along landside levee toe. Fall 2013

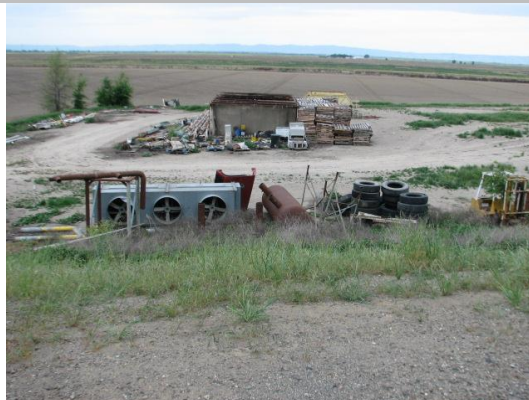
Photo 2 of 2 : johngw\_s\_20140428\_869.jpg

Pieces of machinery and debris at the levee toe. Spring 2014

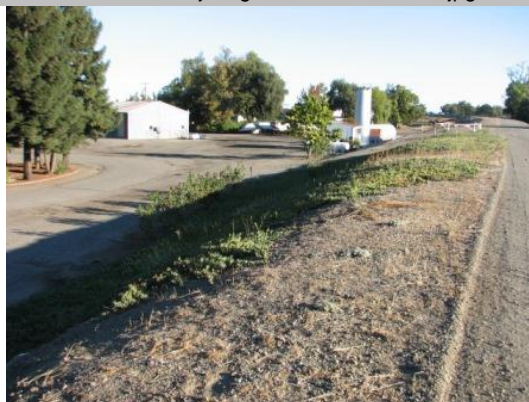
Photo 1 of 1 : johngw\_s\_20140414\_723.jpg

LM Start	2.82	Rating **	M	Issue No.	6
LM End	2.82	Issue Type +	En	Location *	LS
Category	Earthen Levee			GPS Latitude/Longitude	
				Start	End
Item	Vegetation			38.837300 °	38.837300 °
				-121.731775 °	-121.731775 °
DWR ID	DWR_NA0016_01_f_2012_6				
Action/Comments					
Landscaping					
Inspector Comments: River Garden Farms

Landscaping along the slope at River Gardens Farms. Fall 2013

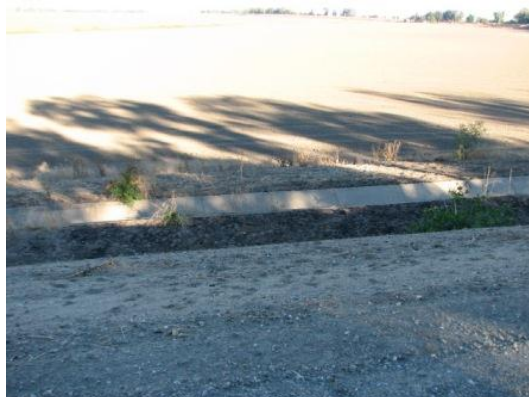
Photo 1 of 1 : johngw\_s\_20140414\_727.jpg

LM Start	3.59	Rating **	A/W	Issue No.	8
LM End	3.97	Issue Type +	Ma	Location *	LS
Category	Earthen Levee			GPS Latitude/Longitude	
				Start	End
Item	Encroachments			38.846767 °	38.850758 °
				-121.729943 °	-121.725263 °
DWR ID	DWR_NA0016_01_s_2012_8				
Action/Comments					
Ditch					
Inspector Comments: concrete lined

A concrete lined ditch runs along the toe of the levee. Fall 2013

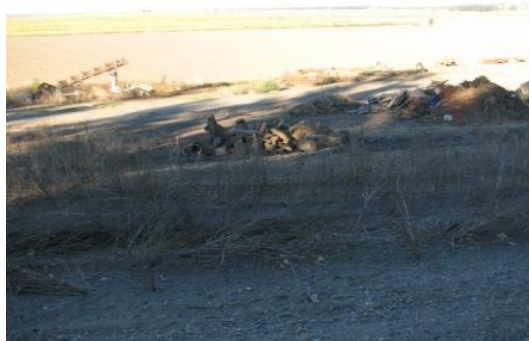
Photo 1 of 3 : johngw\_s\_20140414\_770.jpg

LM Start	4.63	Rating **	M	Issue No.	1551
LM End	4.63	Issue Type +	En	Location *	LS
Category	Earthen Levee			GPS Latitude/Longitude	
				Start	End
Item	Encroachments			38.856995 °	38.856995 °
				-121.730938 °	-121.730938 °
DWR ID	DWR_NA0016_01_f_2013_1551				
Action/Comments					
Debris

A pile of wood trimmings lay along the toe of the levee. Fall 2013

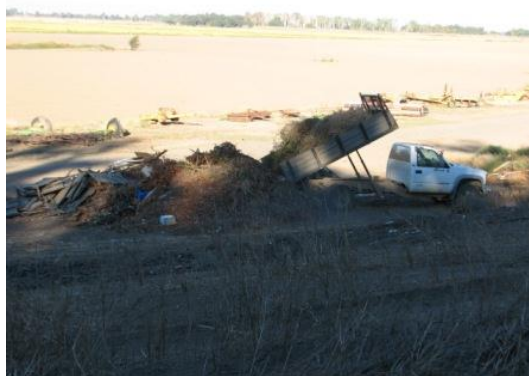
Photo 2 of 3 : johngw\_s\_20140414\_771.jpg

Dumping more debris along with tree trimmings. Fall 2013

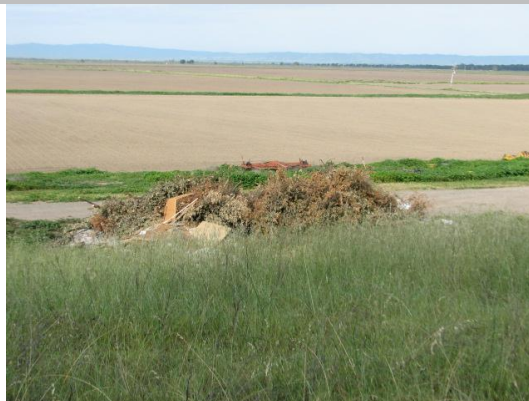
Photo 3 of 3 : johngw\_s\_20140428\_872.jpg

LM Start	4.63	Rating **	M	Issue No.	1551 (cont)
LM End	4.63	Issue Type +	En	Location *	LS
Category	Earthen Levee			GPS Latitude/Longitude	
				Start	End
Item	Encroachments			38.856995 °	38.856995 °
				-121.730938 °	-121.730938 °
DWR ID	DWR_NA0016_01_f_2013_1551				
Action/Comments					
Debris

On going debris pile at the of the levee. Spring 2014

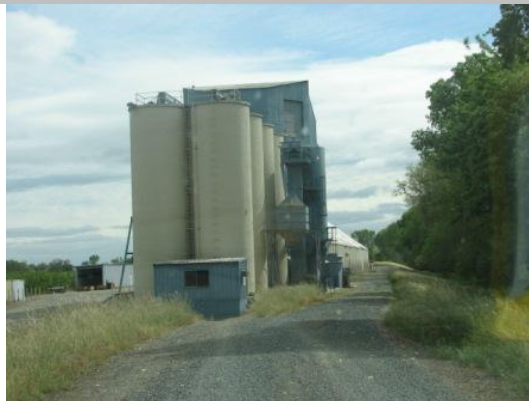
Photo 1 of 1 : johngw\_s\_20140414\_754.jpg

LM Start	19.22	Rating **	M	Issue No.	23
LM End	19.22	Issue Type +	En	Location *	CR
Category	Earthen Levee			GPS Latitude/Longitude	
				Start	End
Item	Encroachments			38.956330 °	38.956330 °
				-121.839277 °	-121.839277 °
DWR ID	DWR_NA0016_01_s_2012_23				
Action/Comments					
Building

Another rice mill on the crown. Photo taken spring 2012.

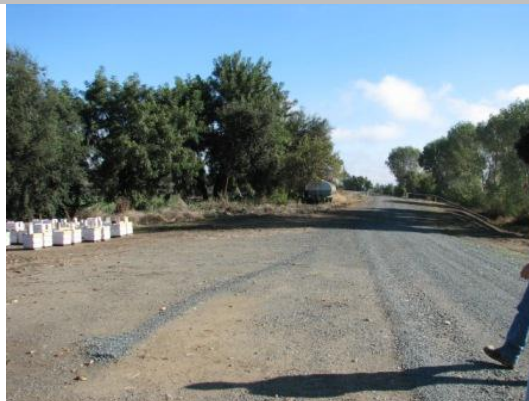
Photo 1 of 1 : johngw\_s\_20140414\_755.jpg

LM Start	19.35	Rating **	M	Issue No.	26
LM End	19.35	Issue Type +	En	Location *	LS
Category	Earthen Levee			GPS Latitude/Longitude	
				Start	End
Item	Encroachments			38.957232 °	38.957232 °
				-121.837258 °	-121.837258 °
DWR ID	DWR_NA0016_01_s _ 2012_26				
Action/Comments					
Equipment

There is equipment on the levee crown and shoulder in the trees. Fall 2011.

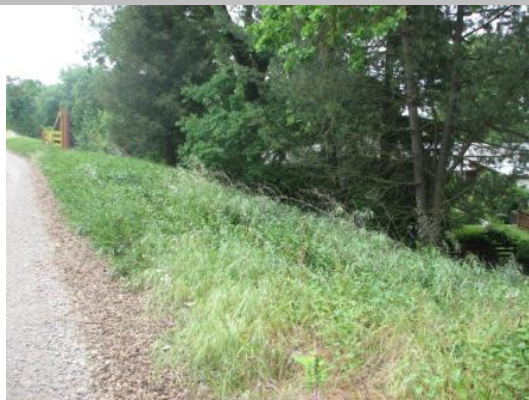
Photo 1 of 1 : johngw\_s\_20140414\_763.jpg

LM Start	25.13	Rating **	M	Issue No.	34
LM End	25.13	Issue Type +	En	Location *	LS
Category	Earthen Levee			GPS Latitude/Longitude	
				Start	End
Item	Vegetation			39.005240 °	39.005240 °
				-121.818123 °	-121.818123 °
DWR ID	DWR_NA0016_01_s_2012_34				
Action/Comments					
Landscaping

The tall grasses blend with the groundcover on the levee slope. Photo taken spring 2012.

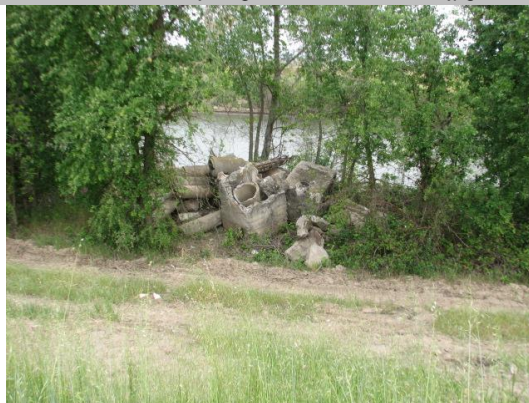
Photo 2 of 2 : johngw\_s\_20140428\_875.jpg

Concrete debris that was on the levee slope is now on the berm area.  
Spring 2014

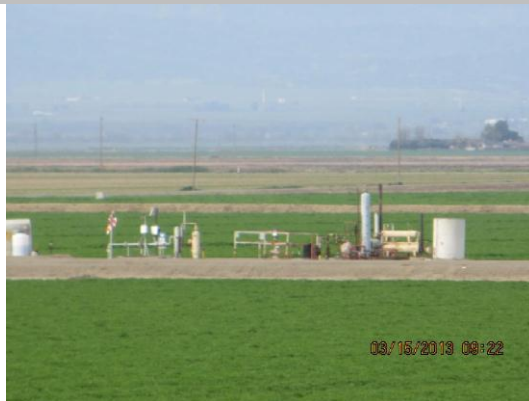
Photo 1 of 1 : UCIP\_328.jpg

LM Start	28.95	Rating **	M	Issue No.	58
LM End	28.95	Issue Type +	En	Location *	WS
Category	Supplemental			GPS Latitude/Longitude	
				Start	End
Item	DWR UCIP Field Study			39.047758 °	39.047758 °
				-121.840914 °	-121.840914 °
DWR ID	DWR_NA0016_01_s _ 2014_58				
Action/Comments					
Inspector Comments: FS_ID:10305

gas well 1500-feet west of this location.

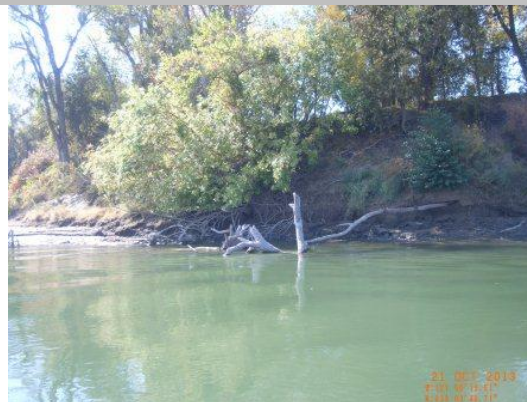
Photo 1 of 1 : USACE2013A\_SAC\_122-0\_R\_5.jpg

LM Start	29.98	Rating **	M	Issue No.	10
LM End	29.98	Issue Type +	Ma	Location *	WS
Category	Supplemental			GPS Latitude/Longitude	
				Start	End
Item	USACE Erosion Survey			39.063209 °	39.063997 °
				-121.838927 °	-121.839335 °
DWR ID					
Action/Comments					
Inspector Comments: 1997 - Mass failure of the lower cohesive bank and toe. 2000 - Still eroding, steeply dipping foresets in the toe are falling off. 2010 - Some new erosion and some new deposition. Eddy current off the upstream rock. 2011 - Still plenty of berm left. 2013: No observed changes. [2013 Site ID: SAC_122-0_R]

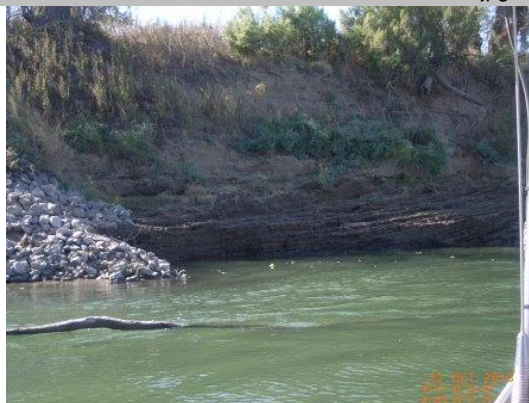
Photo 1 of 1 : USACE2013A\_SAC\_122-3\_R\_6.jpg

LM Start	30.35	Rating **	M	Issue No.	11
LM End	30.35	Issue Type +	Ma	Location *	WS
Category	Supplemental			GPS Latitude/Longitude	
				Start	End
Item	USACE Erosion Survey			39.065886 °	39.066287 °
				-121.842950 °	-121.843602 °
DWR ID					
Action/Comments					
Inspector Comments: 2002 - Upstream end has recent slope failure and exposure of tree roots. 2003 - Some new minor slope erosion with new snags on the bank. 2004 - Appears a little worse. 2005 - Scallop in bank at the upstream end looks worse. 2009 - Minimal new erosion, Berm width is still large, but one large event or one fallen tree and it could go fast. 2010 - New erosion, bank is nearly all vertical from slumping. Site looks bad. 2011 - Site continues to look bad. 2012 - Minor new erosion. 2013: No observed changes. [2013 Site ID: SAC_122-3_R]

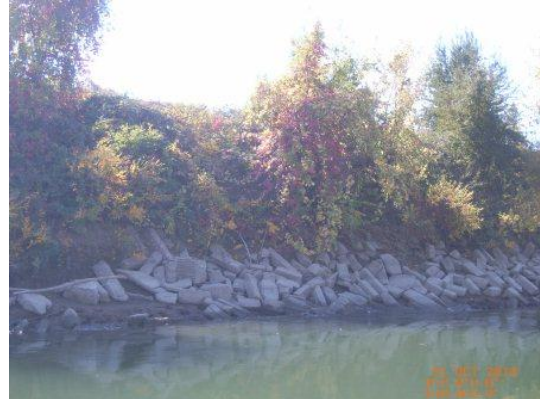
Photo 1 of 1 : USACE2013A\_SAC\_123-7\_R\_3.jpg

LM Start	31.76	Rating **	M	Issue No.	12
LM End	31.78	Issue Type +	Ma	Location *	WS
Category	Supplemental			GPS Latitude/Longitude	
				Start	End
Item	USACE Erosion Survey			39.066901 °	39.067004 °
				-121.867322 °	-121.866913 °
DWR ID					
Action/Comments					
Inspector Comments: 1997 - Erosion into the levee section; old concrete rubble loss at toe; transition between the rock upstream and the cobble downstream. 2000 - Cohesive bench with concrete slabs on top; 25 ft deep scour hole on the downstream end. 2013: No observed changes. [2013 Site ID: SAC_123-7_R]

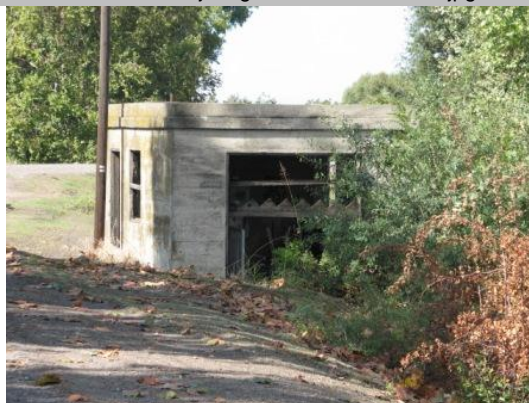
Photo 1 of 1 : johngw\_s\_20140414\_767.jpg

LM Start	32.01	Rating **	M	Issue No.	60
LM End	32.01	Issue Type +	En	Location *	WS
Category	Earthen Levee			GPS Latitude/Longitude	
				Start	End
Item	Encroachments			39.066147 °	39.066147 °
				-121.870425 °	-121.870425 °
DWR ID	DWR_NA0016_01_s _ 2012_60				
Action/Comments					
Building Inspector Comments: Old concrete pumphouse on shoulder open needs to be sealed up.

Old concrete pump house on the waterside levee slope. Fall 2011.

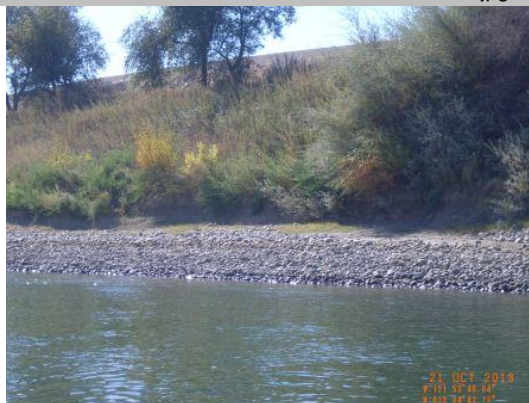
Photo 1 of 1 : USACE2013A\_SAC\_125-6\_R\_5.jpg

LM Start	33.64	Rating **	M	Issue No.	13
LM End	33.64	Issue Type +	Ma	Location *	WS
Category	Supplemental			GPS Latitude/Longitude	
				Start	End
Item	USACE Erosion Survey			39.078340 °	39.079351 °
				-121.894656 °	-121.895317 °
DWR ID					
Action/Comments					
Inspector Comments: 2008 - Slow erosion of the hard toe. 2010 - Cobble rubble is failing, erosion is into the toe of the levee, with vertical slumping.2012 - Site appears to be relatively stable. 2013: New animal holes. [2013 Site ID: SAC_125-6_R]

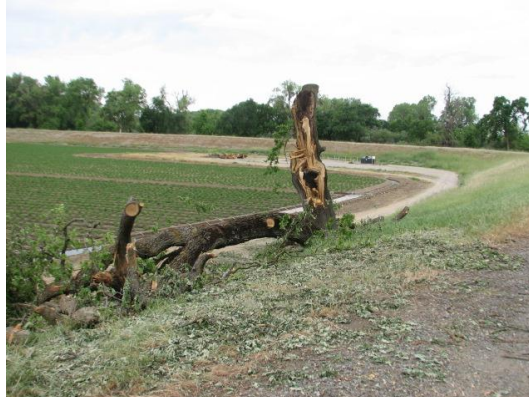
Photo 1 of 1 : johngw\_s\_20140428\_877.jpg

LM Start	34.93	Rating **	M	Issue No.	89
LM End	34.93	Issue Type +	En	Location *	LS
Category	Earthen Levee			GPS Latitude/Longitude	
				Start	End
Item	Encroachments			39.094270 °	39.094270 °
				-121.894837 °	-121.894837 °
DWR ID	DWR_NA0016_01_s_2014_89				
Action/Comments					
Tree or limb

A tree split in half and needs to be removed. Spring 2014

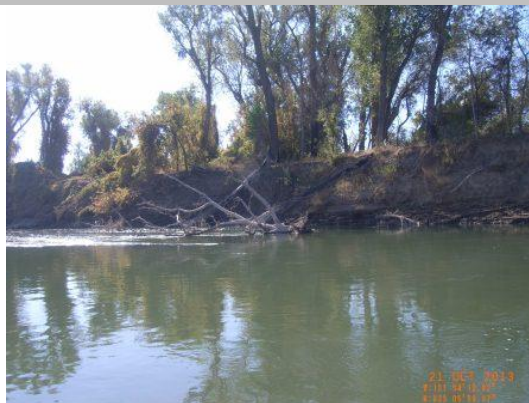
Photo 1 of 1 : USACE2013A\_SAC\_127-9\_R\_5.jpg

LM Start	35.71	Rating **	M	Issue No.	17
LM End	35.72	Issue Type +	Ma	Location *	WS
Category	Supplemental			GPS Latitude/Longitude	
				Start	End
Item	USACE Erosion Survey			39.100836 °	39.099482 °
				-121.904320 °	-121.903430 °
DWR ID					
Action/Comments					
Inspector Comments: 1997 - Major scour off the downstream end of existing rock, creating a scour pocket where the levee starts diverging from the bankline. 2000 - Some minor erosion, 20 ft deep hole at downstream end. 2004 - Small amount of new erosion. 2010 - Bad transition off downstream end of rock revetment, some new erosion. 2012 - Site extended downstream, minor new erosion. 2013: Minor new erosion. [2013 Site ID: SAC_127-9_R]

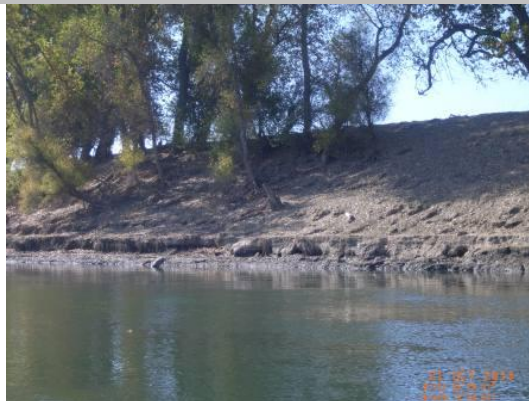
Photo 1 of 1 : USACE2013A\_SAC\_136-6\_R\_5.jpg

LM Start	43.39	Rating **	M	Issue No.	19
LM End	43.39	Issue Type +	Ma	Location *	WS
Category	Supplemental			GPS Latitude/Longitude	
				Start	End
Item	USACE Erosion Survey			39.172501 °	39.174949 °
				-121.939053 °	-121.940737 °
DWR ID					
Action/Comments					
Inspector Comments: 2010 - Lower portion of 136.7 that did not extend far enough. Abrupt transition from upstream site. 2012 - Site extended upstream, minor new erosion. 2013: Minor new erosion at the toe.					
New tree popouDownstream limit extended. [2013 Site ID: SAC_136-6_R]

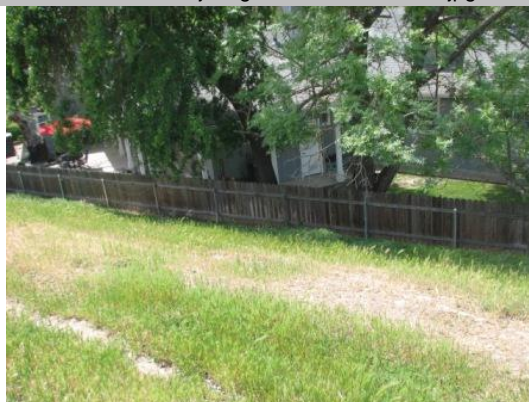
Photo 1 of 1 : johngw\_s\_20140414\_764.jpg

LM Start	43.76	Rating **	M	Issue No.	46
LM End	43.76	Issue Type +	En	Location *	LS
Category	Earthen Levee			GPS Latitude/Longitude	
				Start	End
Item	Encroachments			39.176429 °	39.176429 °
				-121.942889 °	-121.942889 °
DWR ID	DWR_NA0016_01_s_2012_46				
Action/Comments					
Fence

A solid fence along the toe of the levee. Photo taken spring 2012.

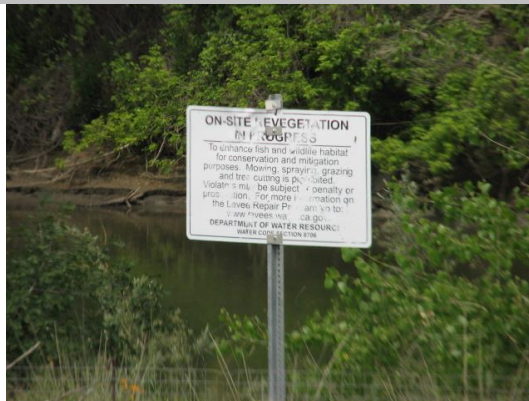
Photo 1 of 1 : johngw\_s\_20140428\_876.jpg

LM Start	47.74	Rating **	A/W	Issue No.	90
LM End	48.17	Issue Type +	Ob	Location *	WS
Category	Earthen Levee			GPS Latitude/Longitude	
				Start	End
Item	Vegetation			39.189930 °	39.193491 °
				-121.982143 °	-121.988184 °
DWR ID	DWR_NA0016_01_s_2014_90				
Action/Comments					
Environmental Requirements.

A revegetation site along the waterside berm. Spring 2014

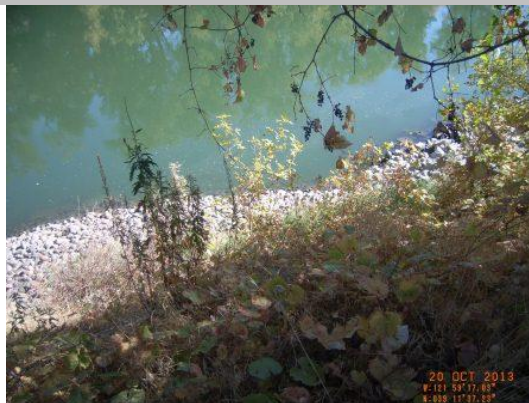
Photo 1 of 1 : USACE2013A\_SAC\_141-5\_R\_6.jpg

LM Start	48.05	Rating **	M	Issue No.	20
LM End	48.05	Issue Type +	Ma	Location *	WS
Category	Supplemental			GPS Latitude/Longitude	
				Start	End
Item	USACE Erosion Survey			39.193769 °	39.195595 °
				-121.987901 °	-121.988621 °
DWR ID					
Action/Comments					
Inspector Comments: 2010 - Old cobble site starting to unravel at toe. 2011 - Cobbles continue to unravel. 2013: Site extended downstream to revetment. [2013 Site ID: SAC_141-5_R]

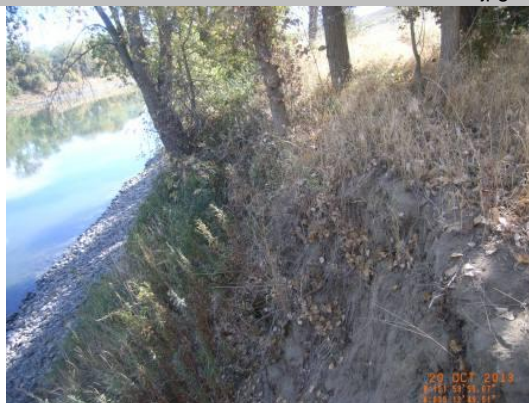
Photo 1 of 1 : USACE2013A\_SAC\_143-5\_R\_8.jpg

LM Start	50.03	Rating **	M	Issue No.	21
LM End	50.03	Issue Type +	Ma	Location *	WS
Category	Supplemental			GPS Latitude/Longitude	
				Start	End
Item	USACE Erosion Survey			39.213608 °	39.213869 °
				-121.997543 °	-121.999641 °
DWR ID					
Action/Comments					
Inspector Comments: 2011 - Multiple scallops, one tree pop out. Old cobble site starting to unravel at midbank. 2012 - Mid bank slumping continues to worsen but cobble at the toe appears stable2013: No observed changes. [2013 Site ID: SAC_143-5_R]
